California State Board of Equalization
450 N Street, Sacramento, California

**Mold Remediation – Third Floor
Closure Report Addendum**
Project No. 2372.02-572

Closure Report Date: June 18, 2010

Addendum Date: October 31, 2012

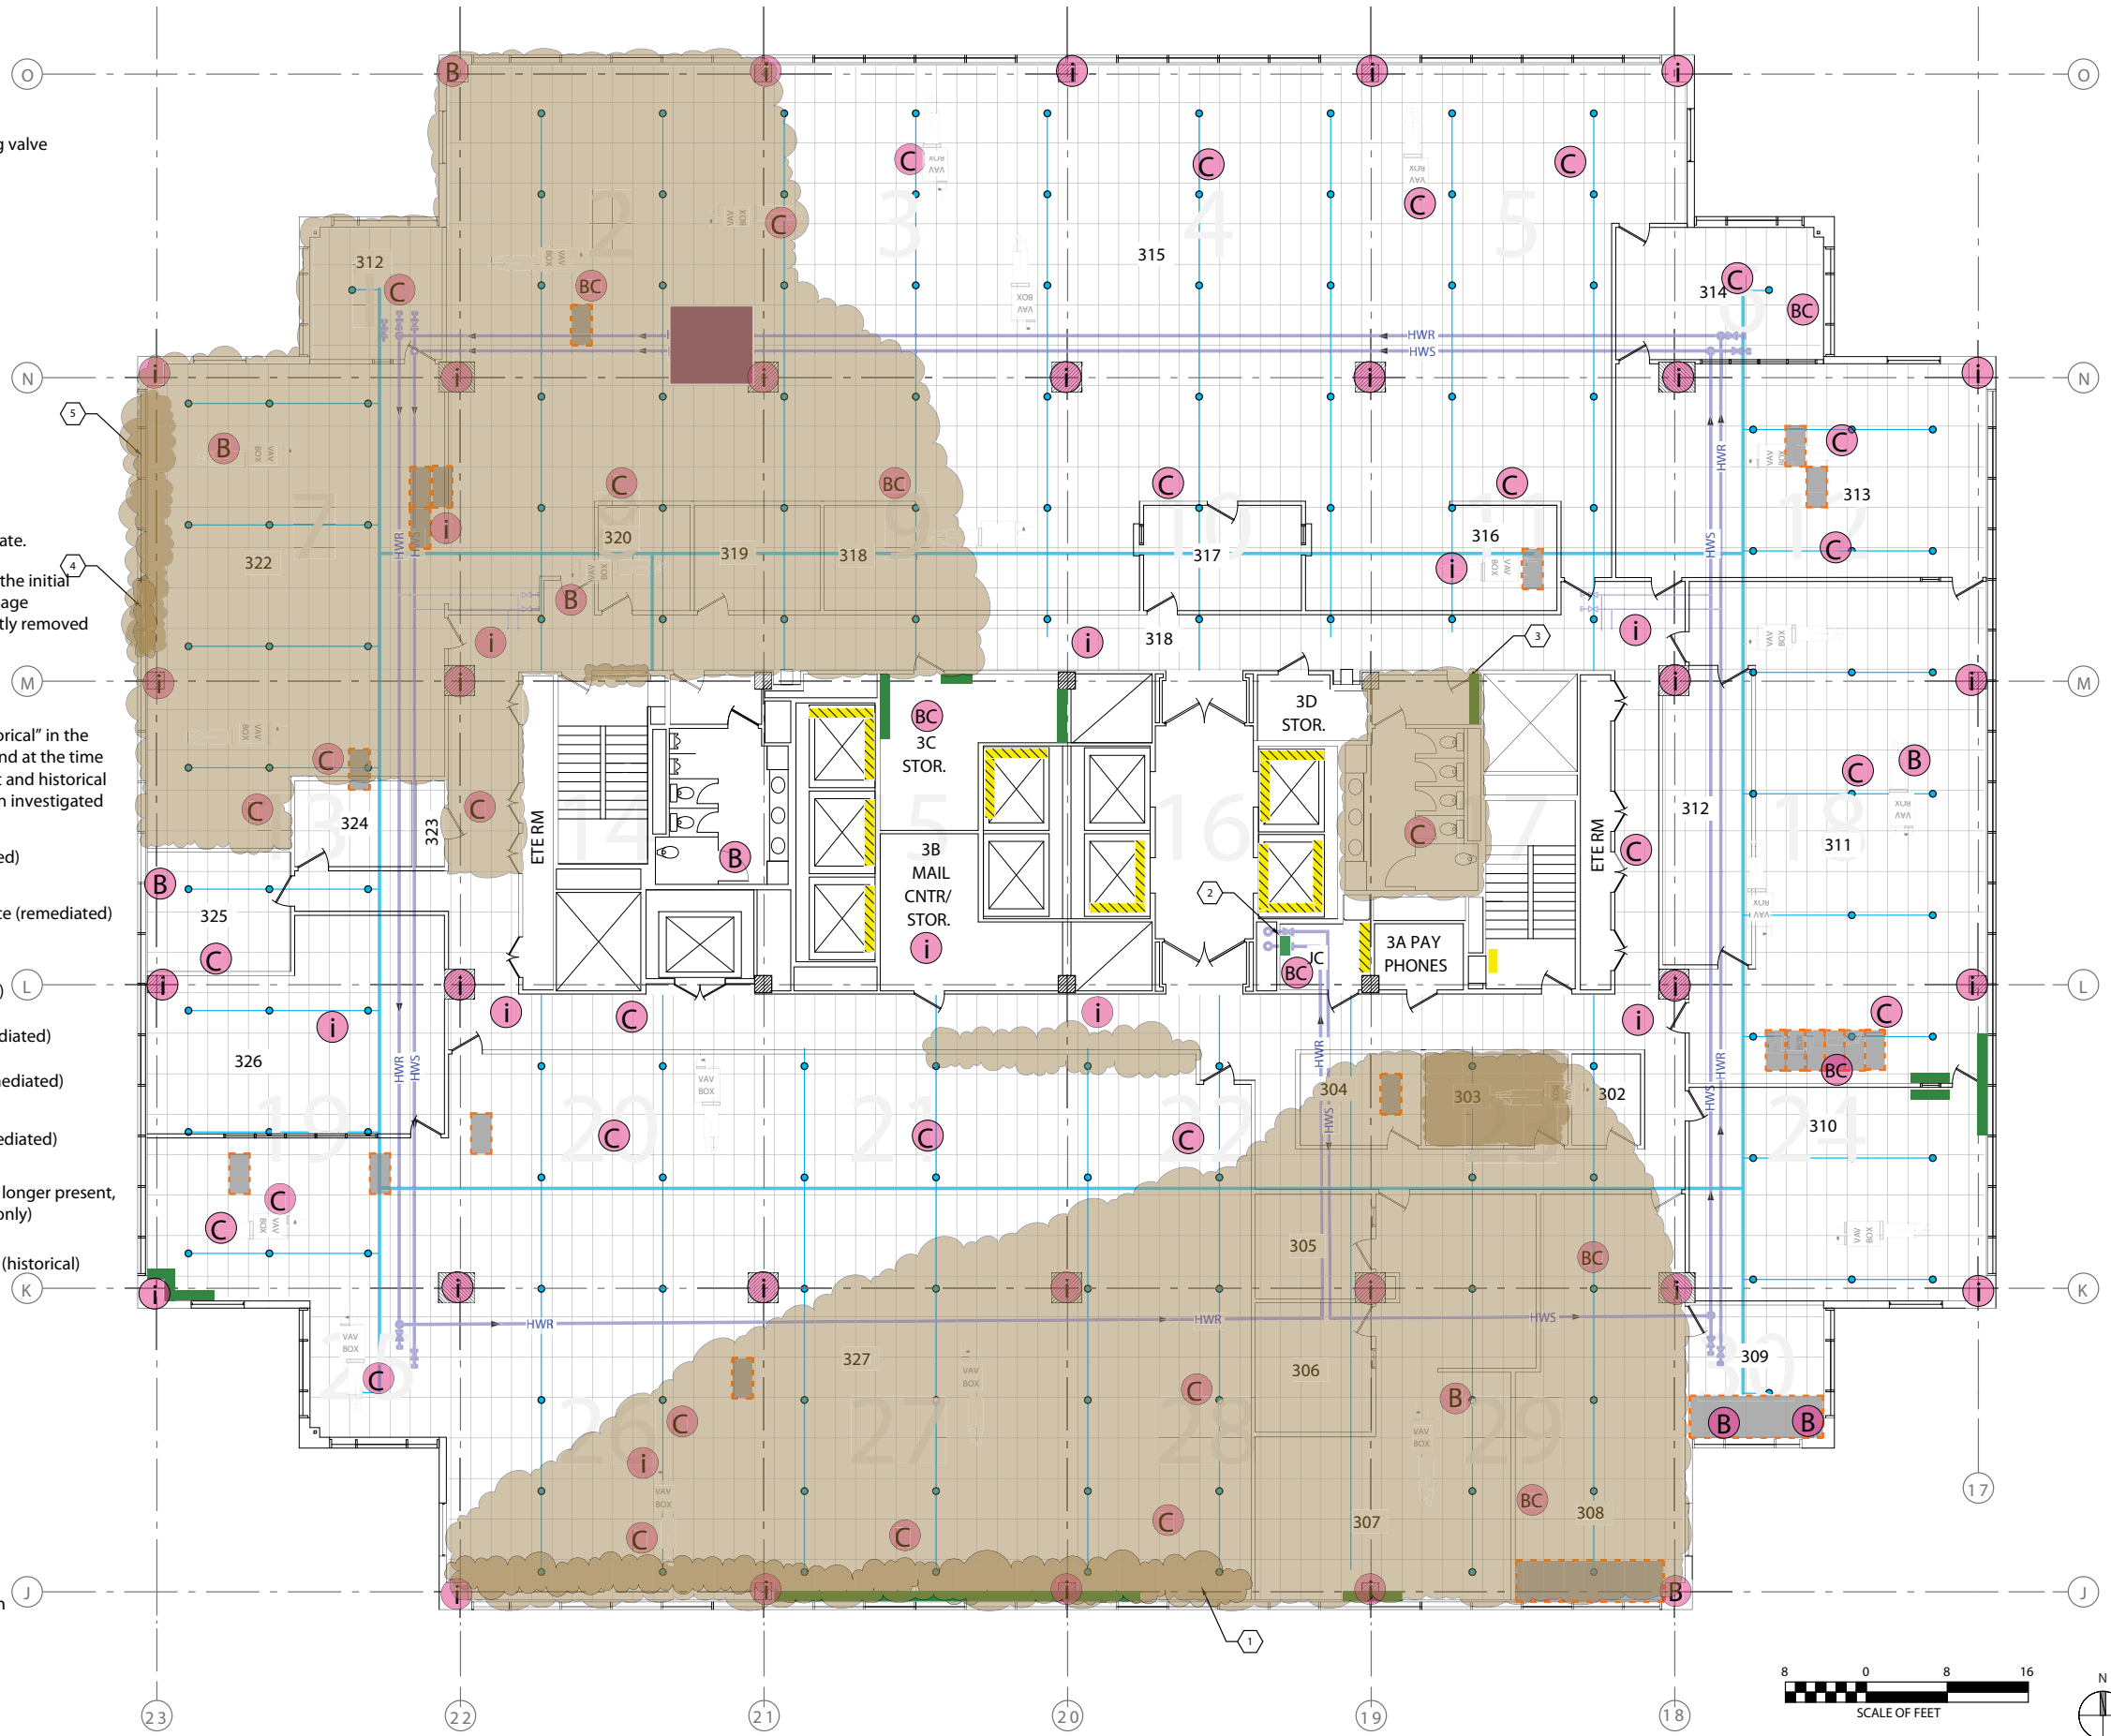
Figure 1

- 1 Line of wet carpet, broken sprinkler (historical)
- 2 1 square foot mold at ceiling valve
- 3 Periodic toilet overflows
- 4 Leaking window (historical)
- 5 Roof water enters under wall (historical)

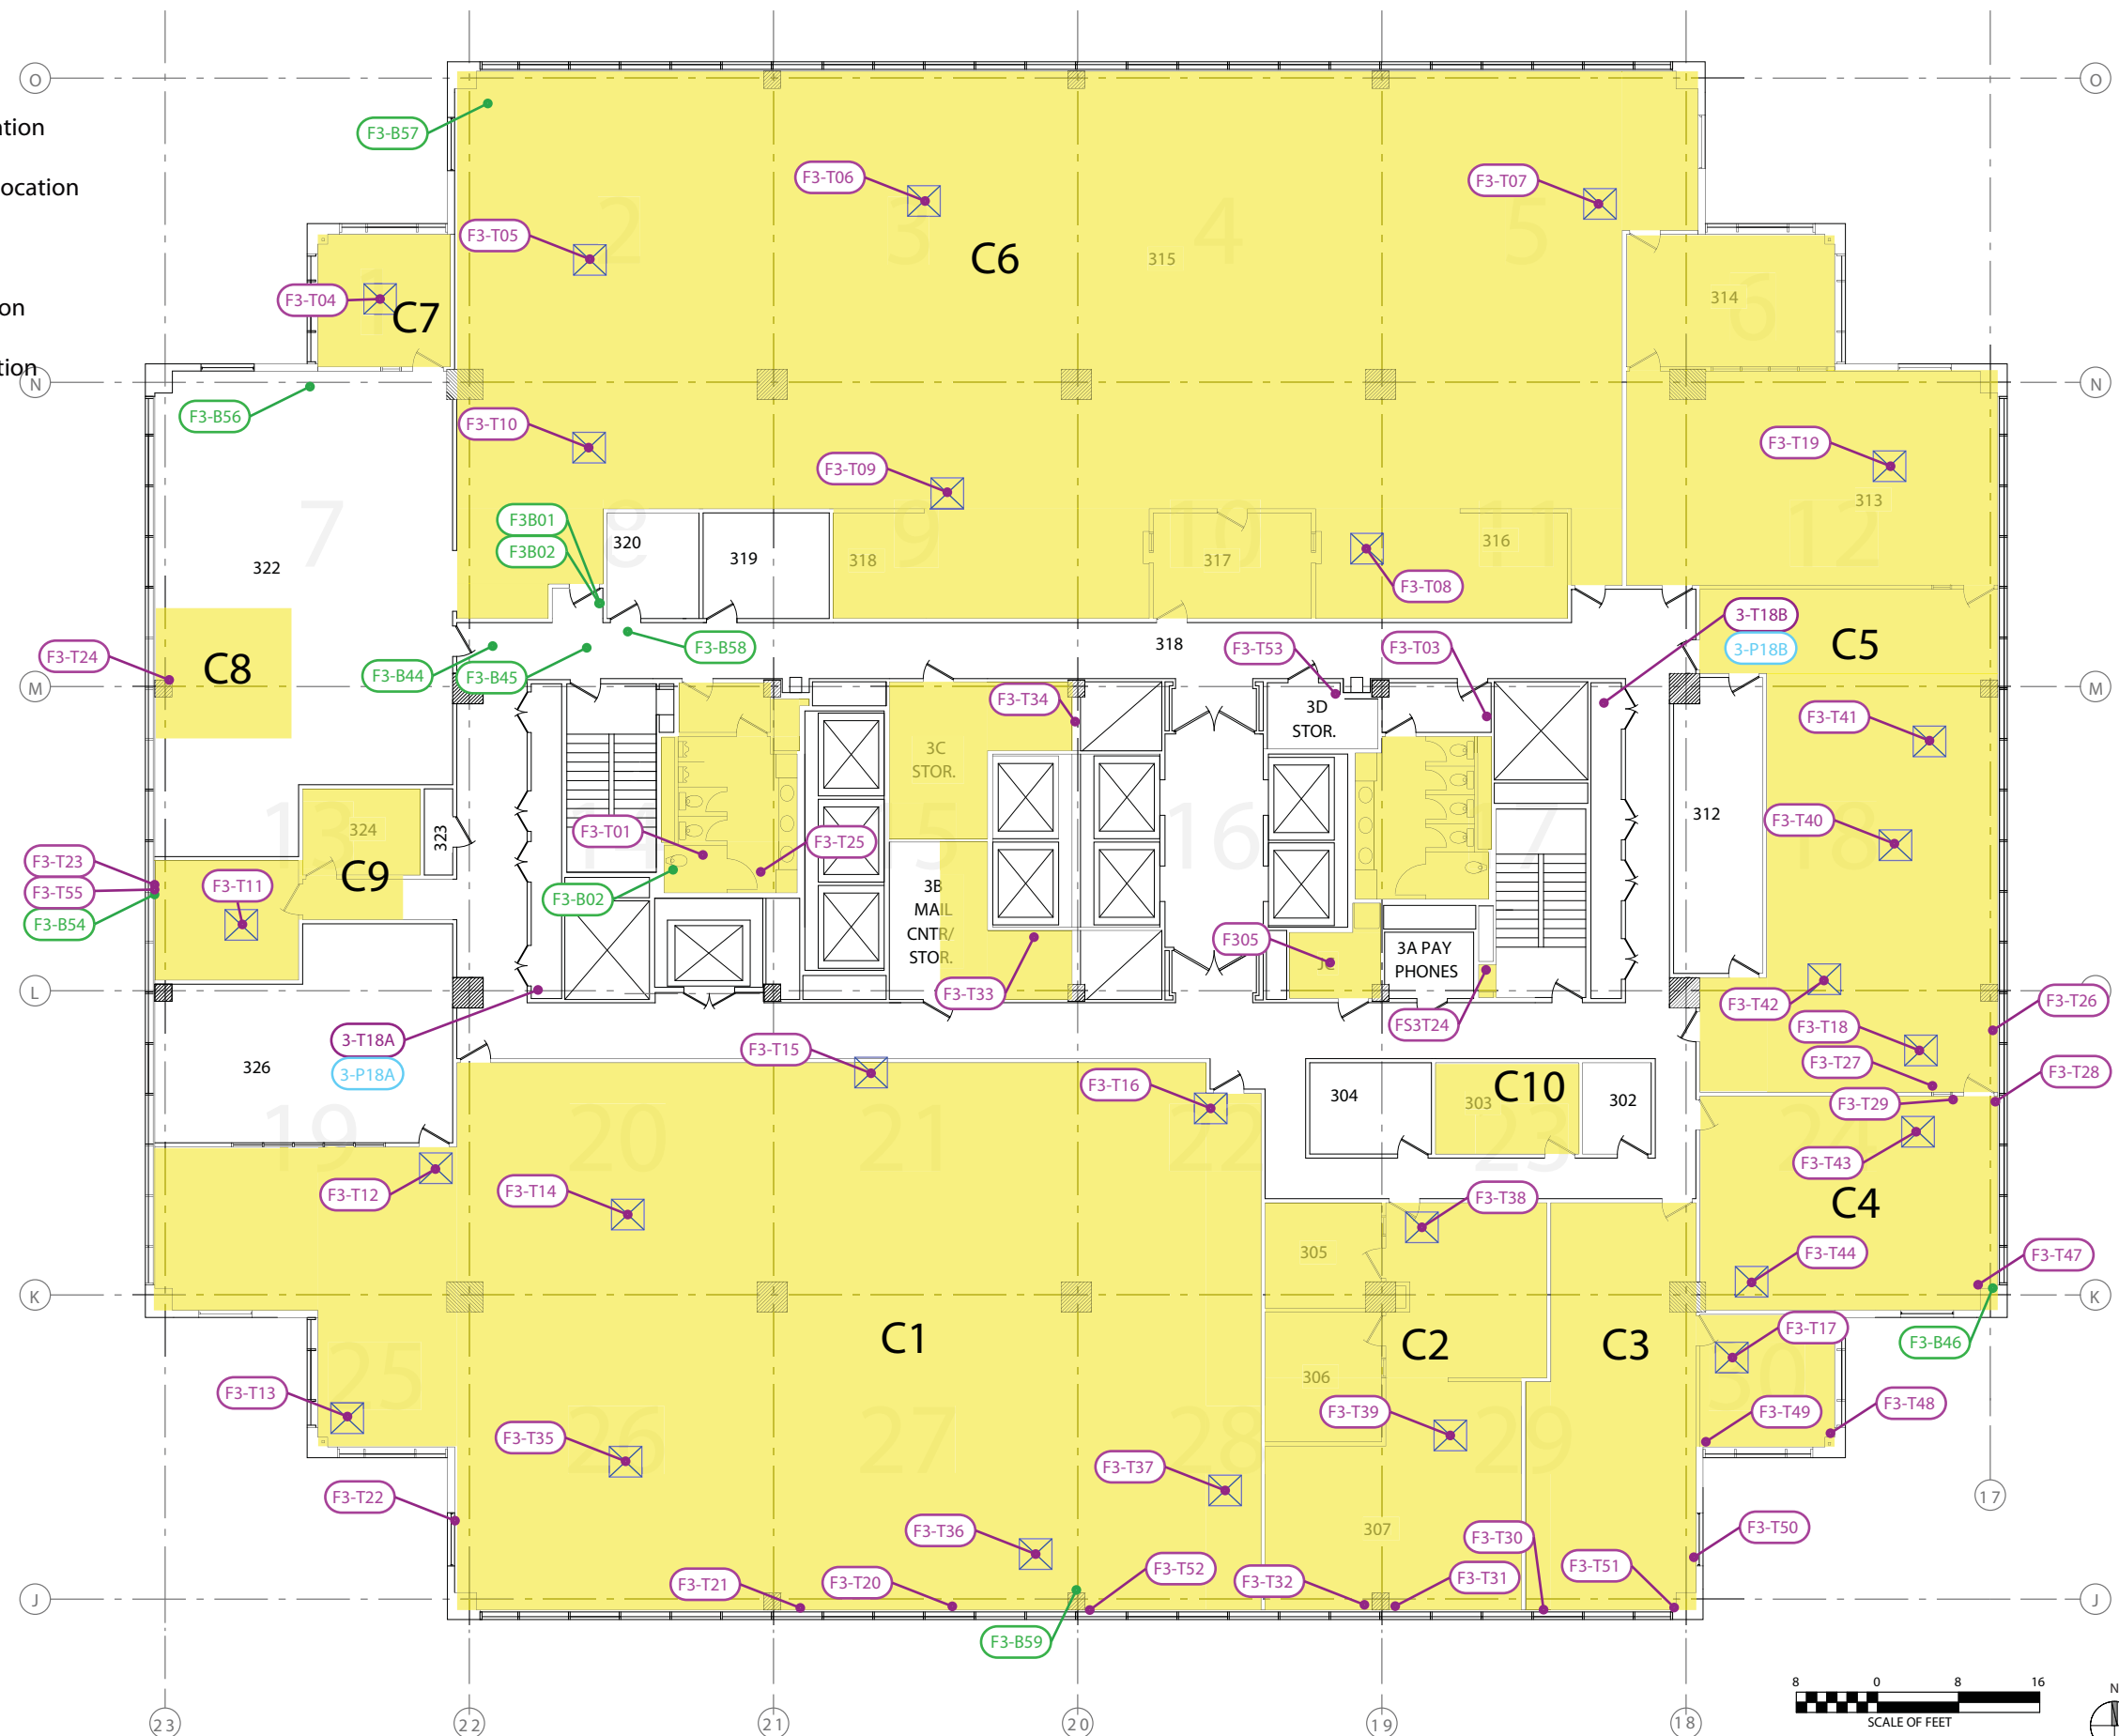
Subsequent to the completion of the closure report, a need for additional investigation and/or remediation activities was identified. Identified areas were subjected to sampling. Using a combination of surface tape lift and/or bulk samples, LCD tested stains on walls and other building materials to determine if the stains were indicative of mold growth. The sample locations are depicted in a revised Figure 2 attached to this addendum.
